# Iron-Enhanced Swale Ditch Checks for Phosphorus Retention

Research Report  
Final Report 2019-27

# IRON-ENHANCED SWALE DITCH CHECKS FOR PHOSPHORUS RETENTION

## FINAL REPORT

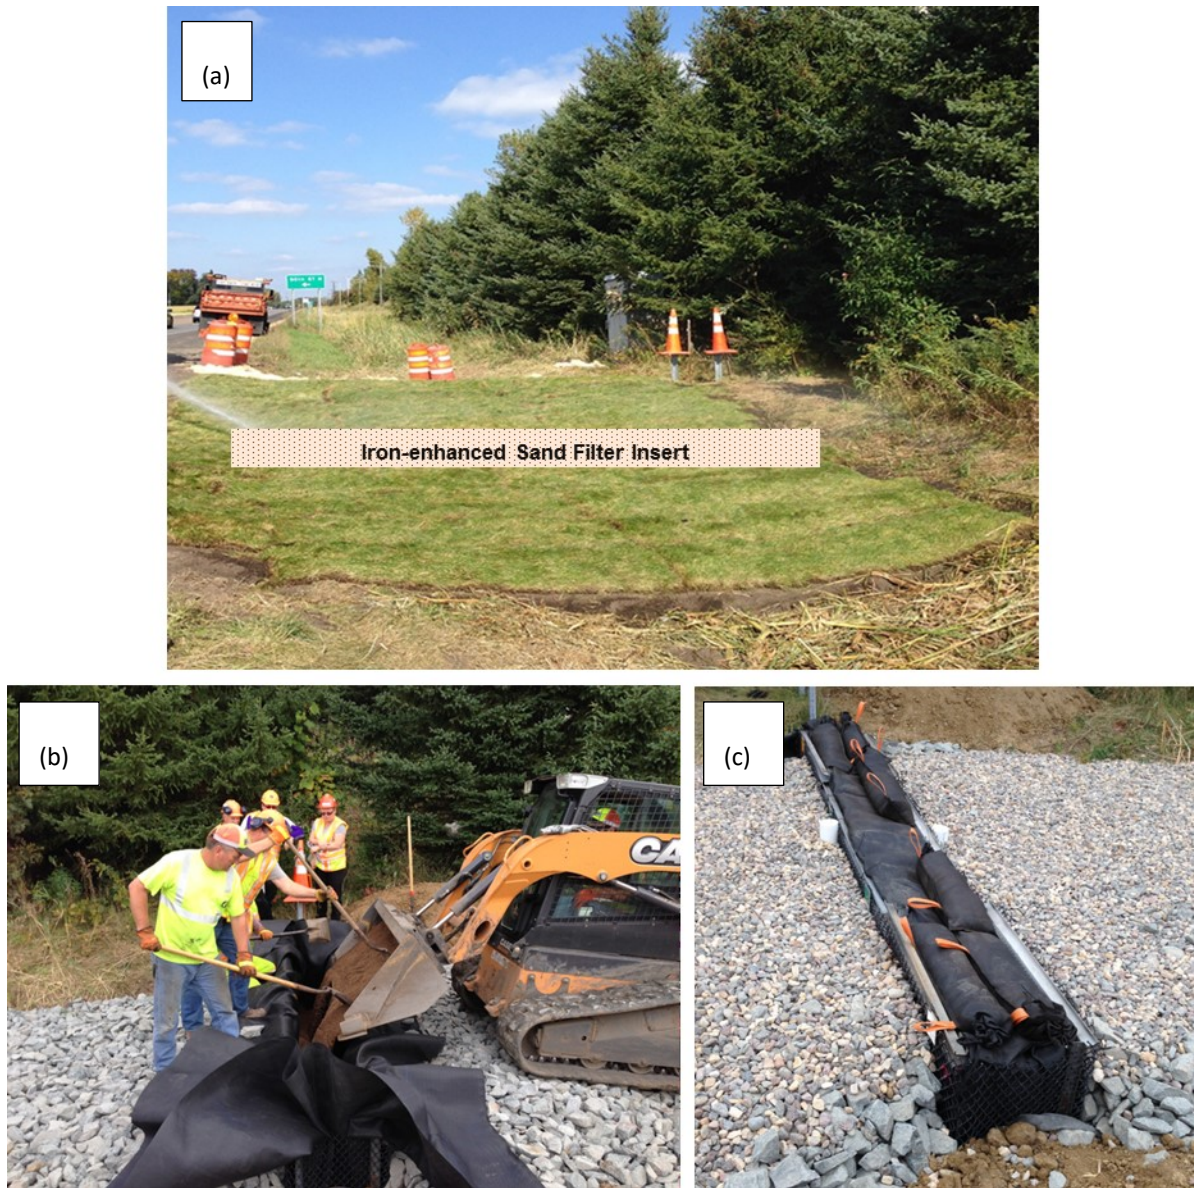
**Figure 2.3. (a) Photograph of the iron-enhanced ditch check (Ditch Check 2) along CR 15 (formerly TH 5) in Stillwater, Washington County (Photograph by P. Natarajan, 2014). Approximate location of the filter insert in the ditch check is shown. (b) Photograph taken during construction in 2014 shows the placement of filter media into a single geotextile fabric that was wrapped to form the filter insert core inside the filter cage, and (c) Photograph shows the completed filter insert.**

Figure 2.3 2.3). The drainage area to Ditch Check 2 is 0.29 ha (0.72 ac), consisting of 0.21 ha (0.52 ac) of swales and 0.08 ha (0.20 ac) of highway area. The iron-enhanced sand filter insert spans the entire width of the ditch (~3.81 m or 12.5 ft), and is 0.40 m (16 in) long in the direction of flow. The ditch check is approximately 0.61 m (2 ft) high and is fully covered by topsoil and sod (

Figure 2.3). The topsoil and sod cover was required for roadside clear zone safety since bare riprap was considered a hazard.

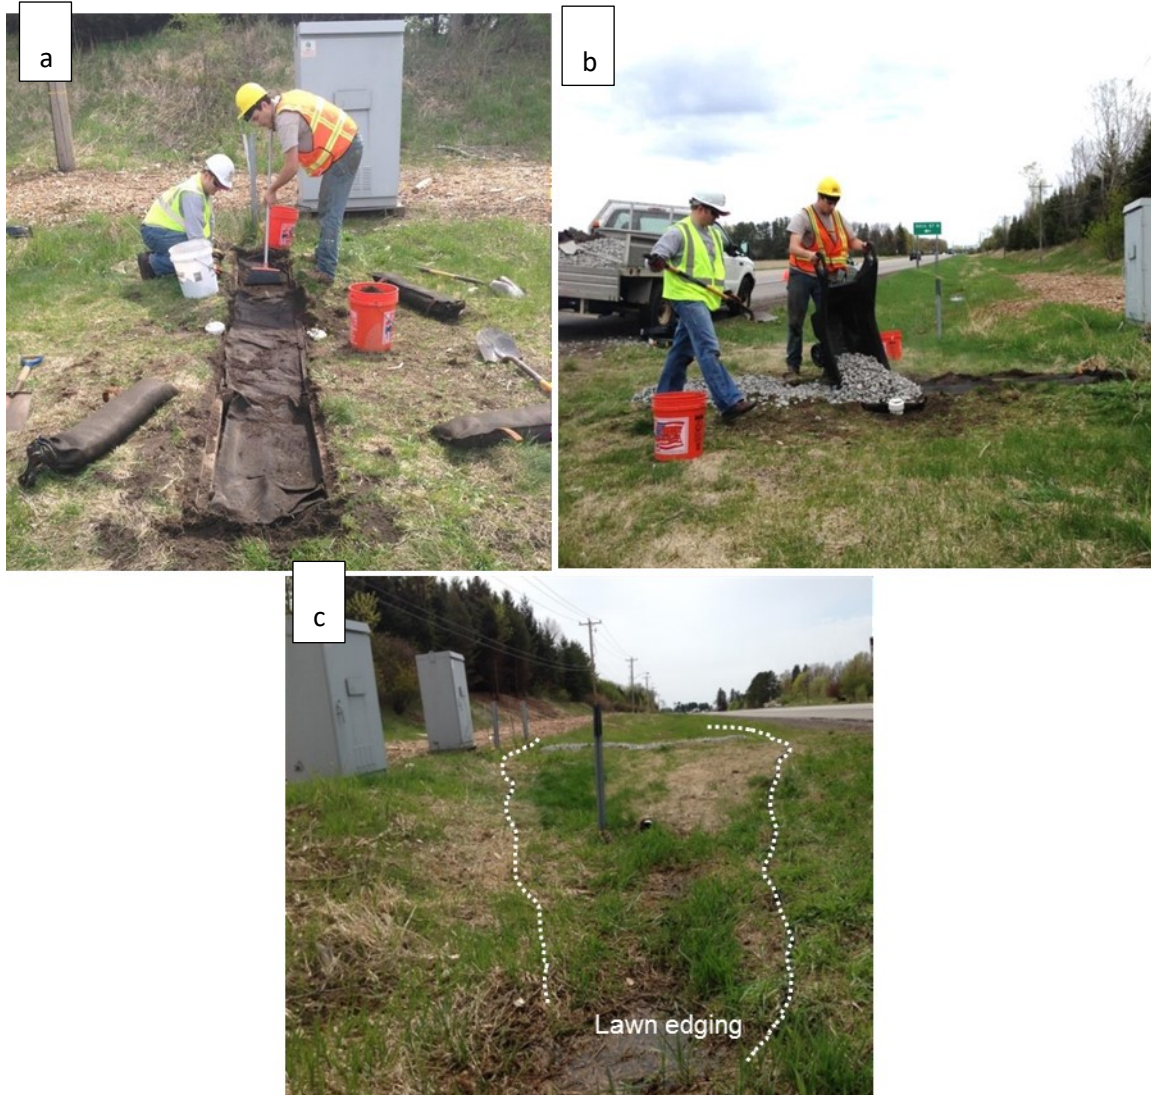
**Figure 4.1.** Maintenance performed at the ditch check site in May 2017. The topsoil and sod covering the filter insert section were removed (a & b), and lawn edging (highlighted by white dashed line) was installed along the ditch check (c).

In May 2017, the sod and topsoil covering the filter insert section was removed and replaced with washed river rock (~2.54 cm or 1 inch size) (Figure 4.1a, b). The sod cover on the remaining surface of the ditch check was not disturbed. Second, lawn edging was installed along the entire length of the ditch check feature on the roadway side (in-slope) and the back-slope to divert sheet flow away from the ditch check (Figure 4.1c). Monitoring began after these maintenance actions.
